Geotechnical
Environmental and
Water Resources
Engineering

Re: Monthly Remedial Monitoring Report No. 2
50 Tufts Street Site
Somerville, MA
RTN 3-26114

Remedial Monitoring Report No. 2
50 Tufts Street
Somerville, Massachusetts

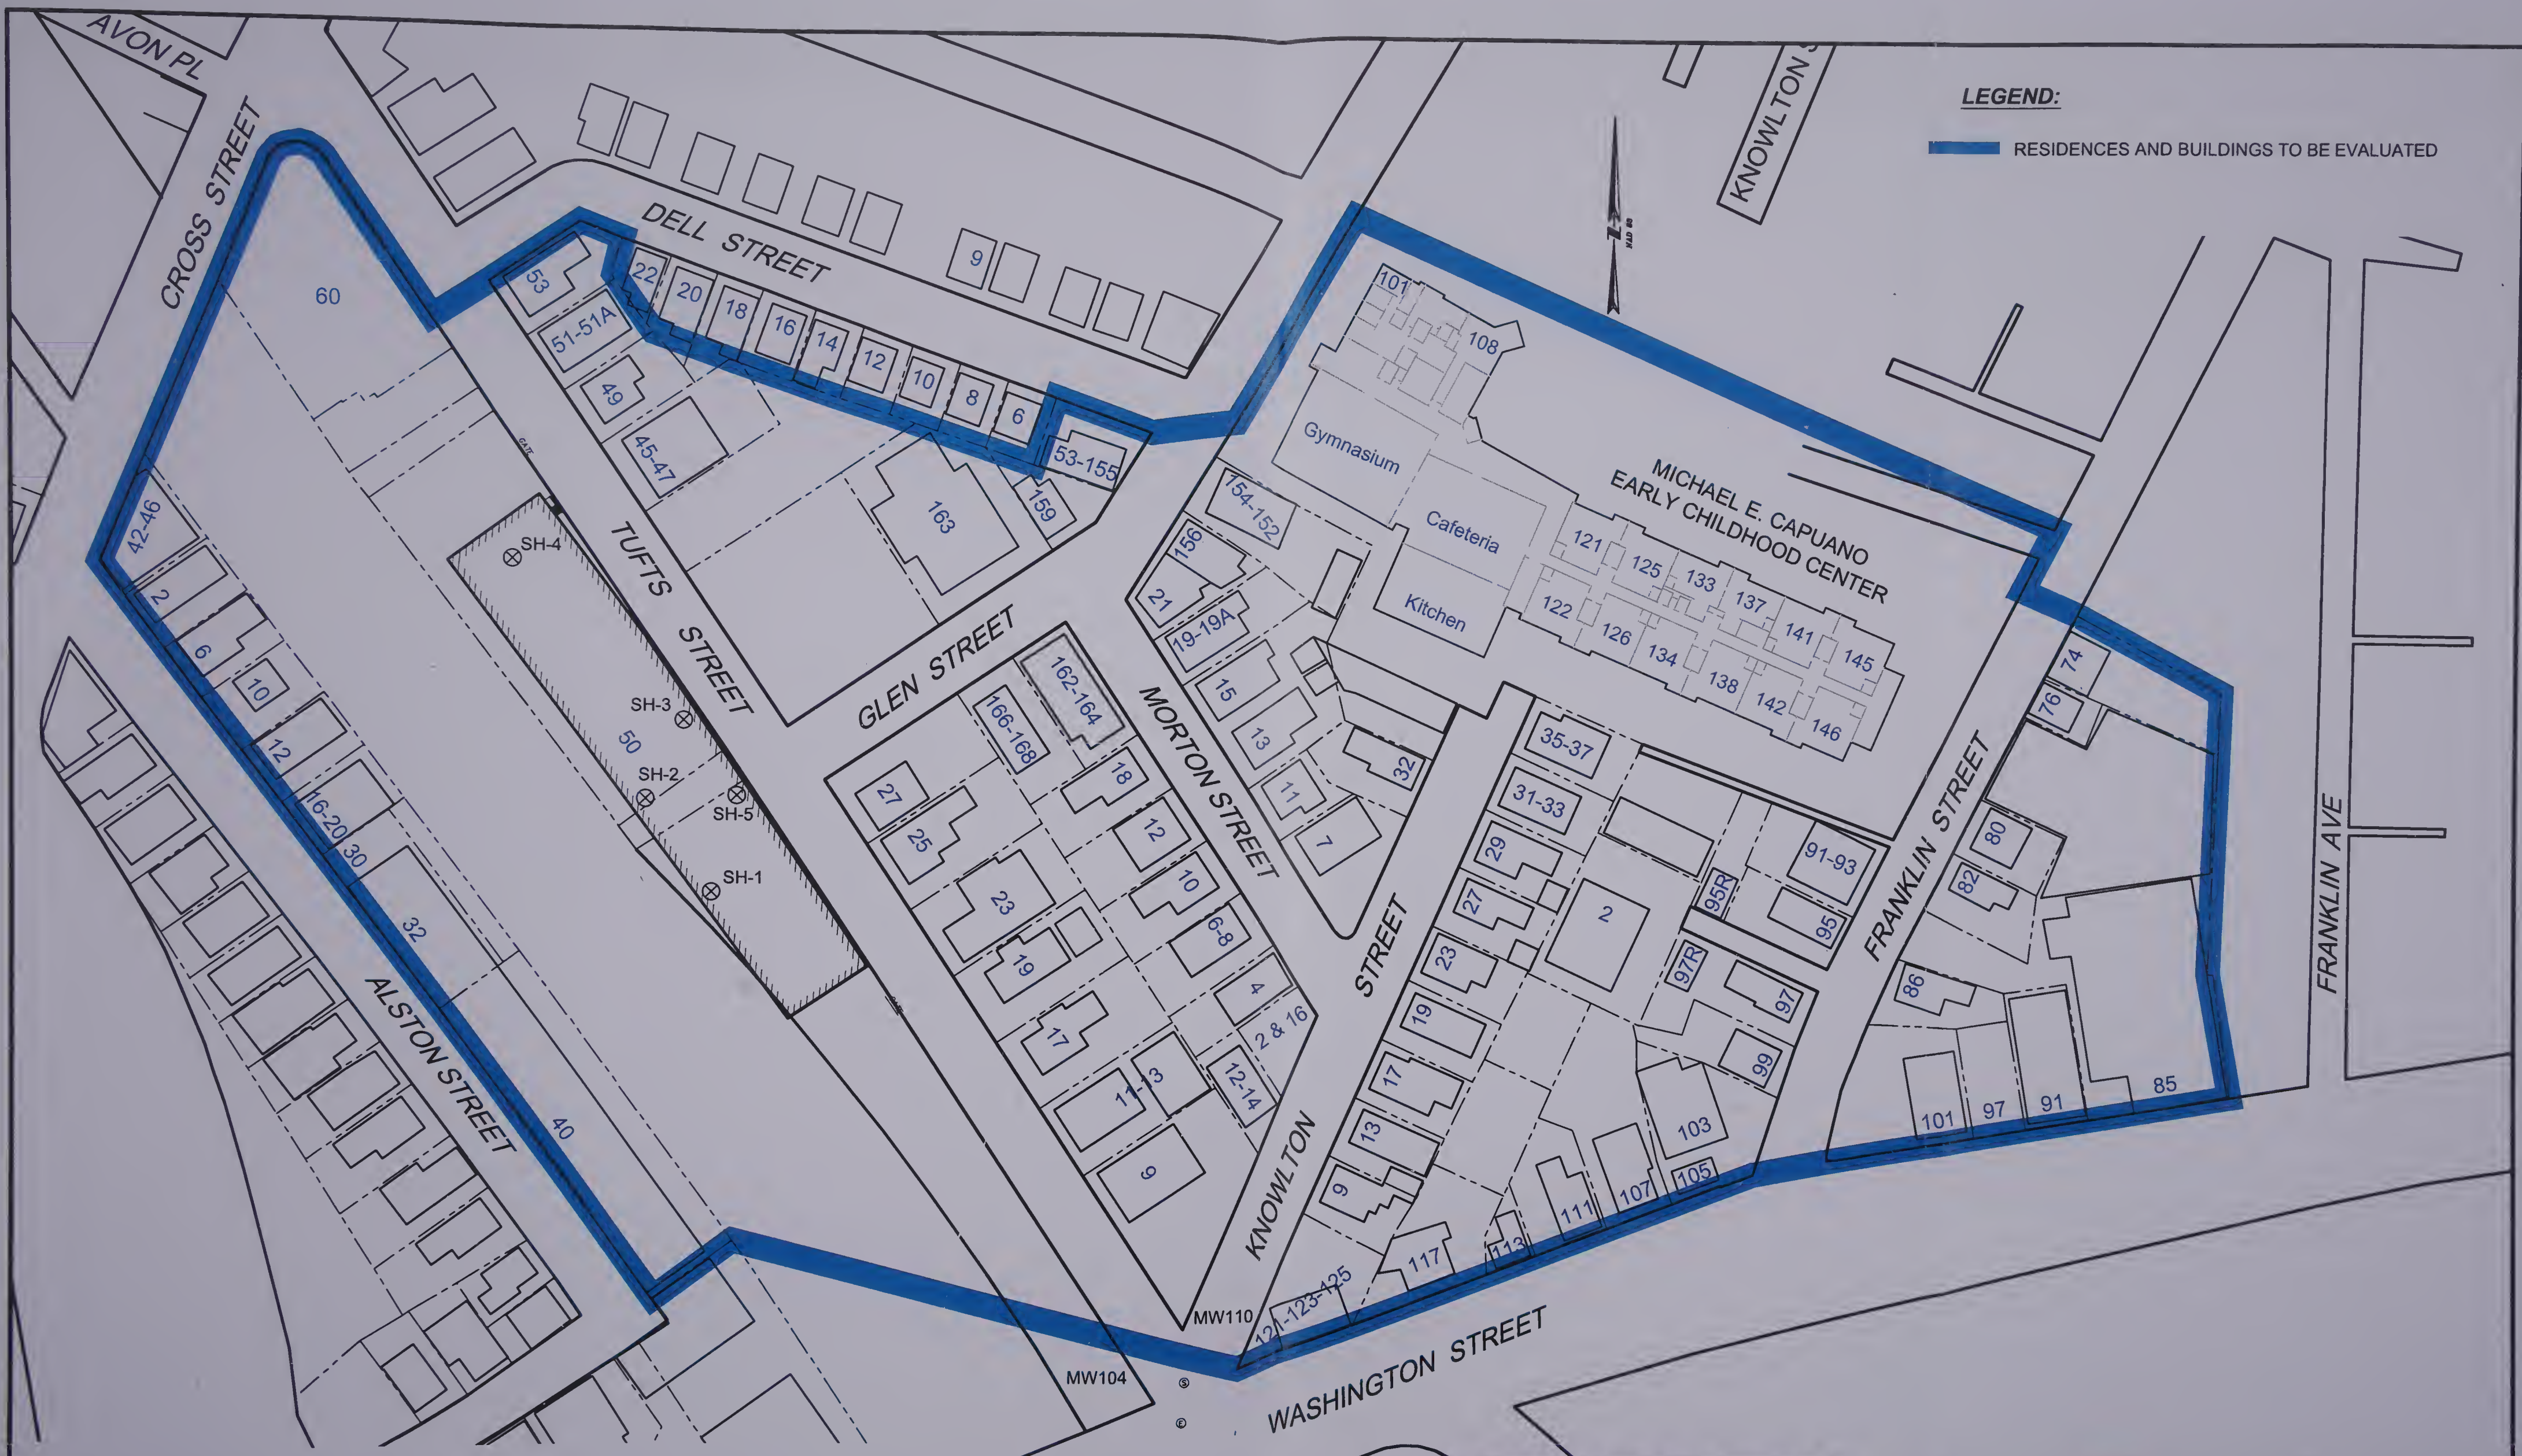
Fig. 2

50 TUFTS STREET SITE

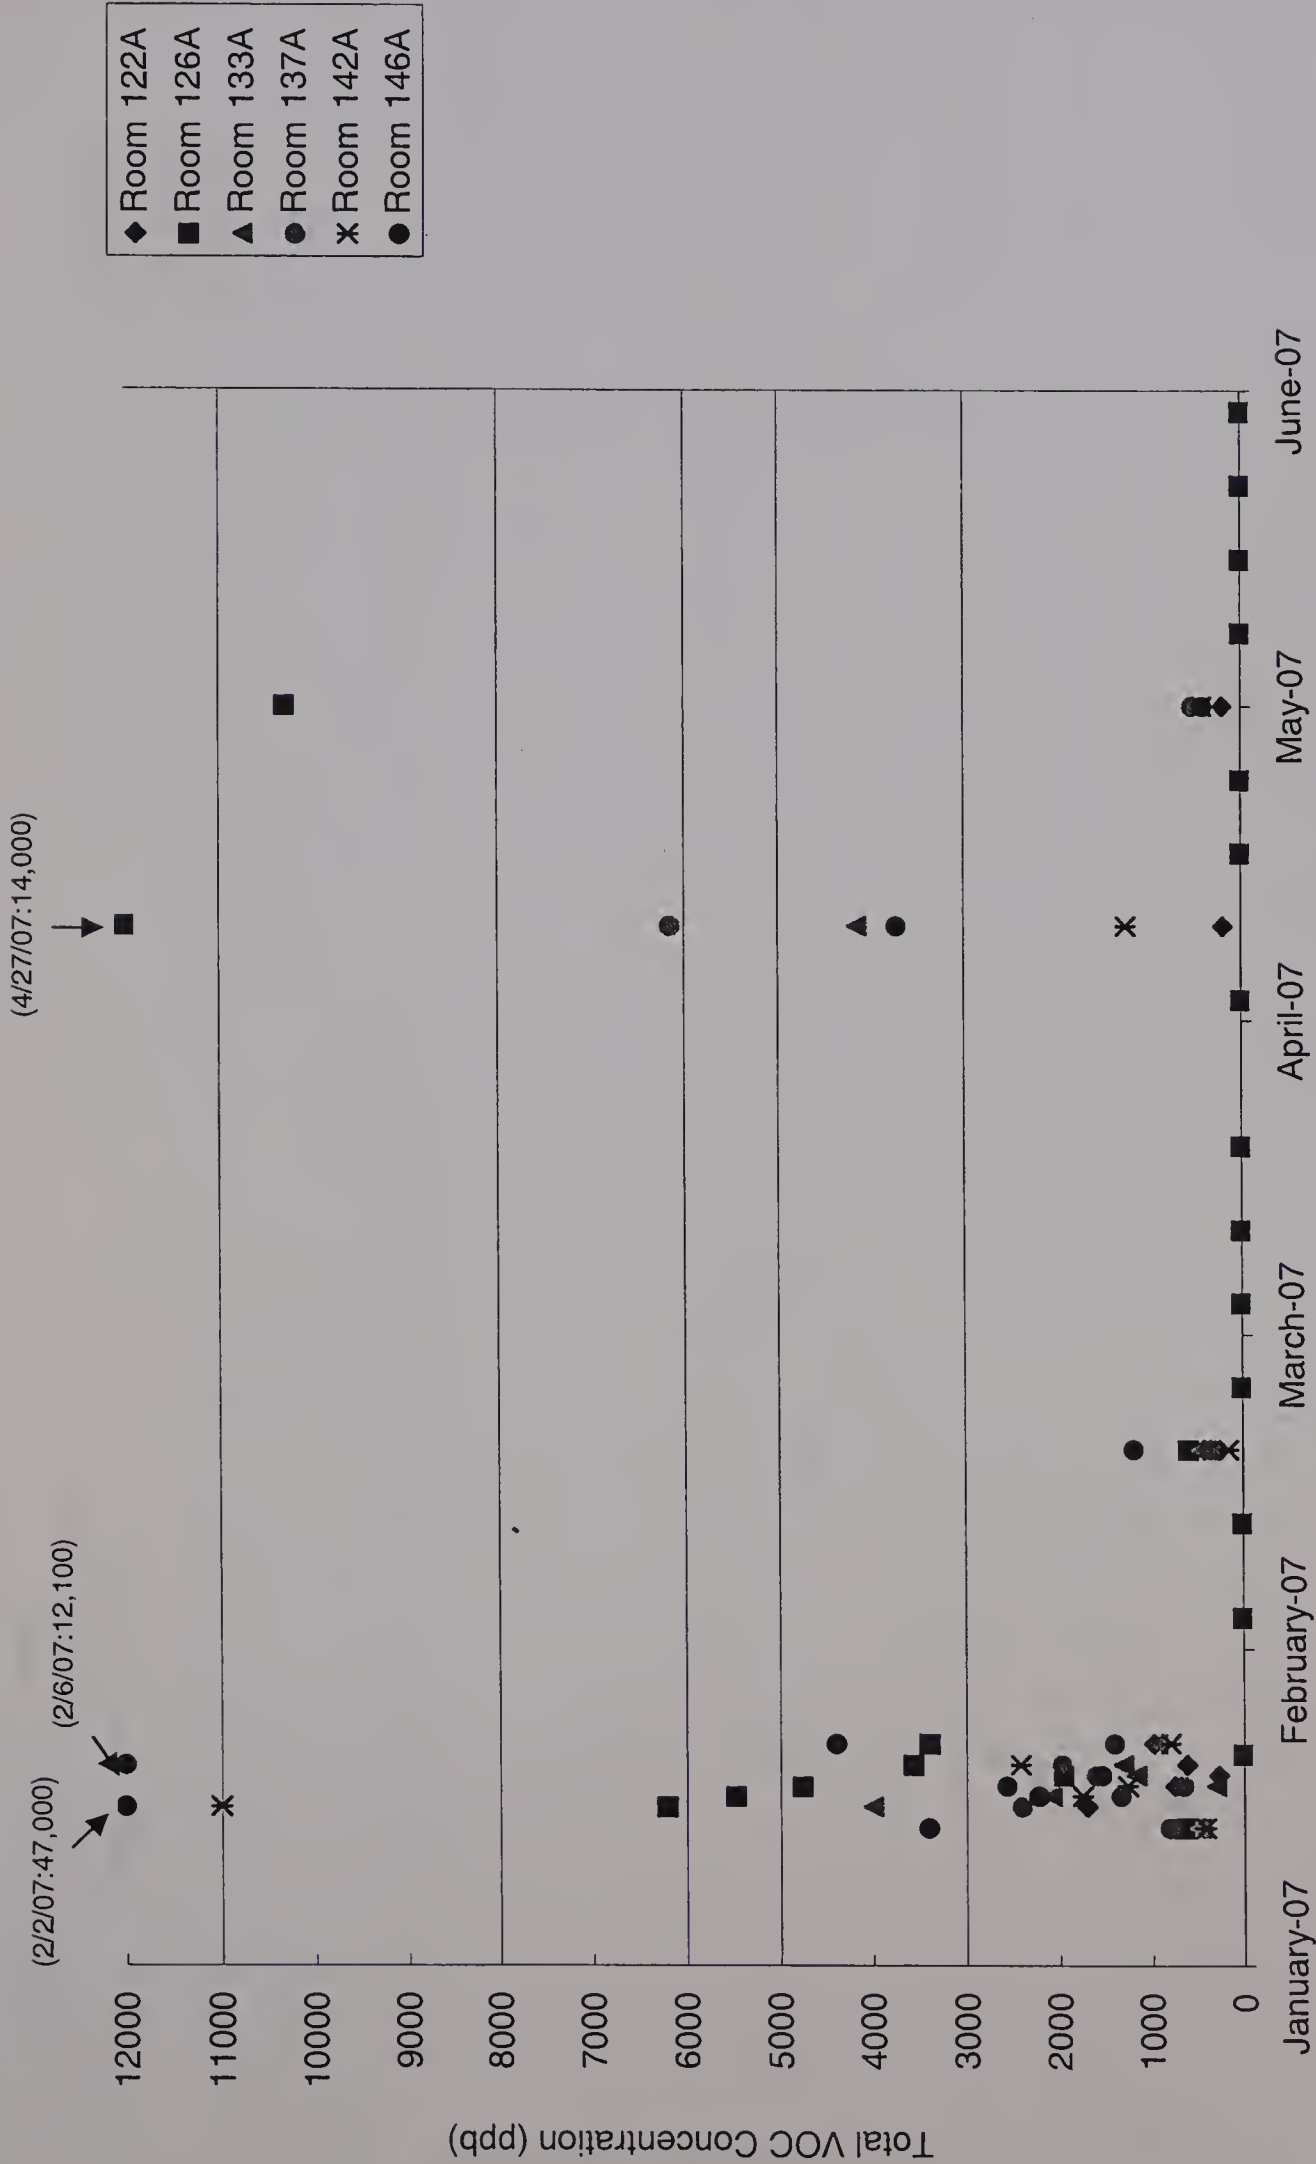
Graph 2

PID Monitoring Data: January 31, 2007 - May 31, 2007
Total VOC Concentrations by PID at Interior Sub-Slab Monitoring Points
Capuano Center
Somerville, MA

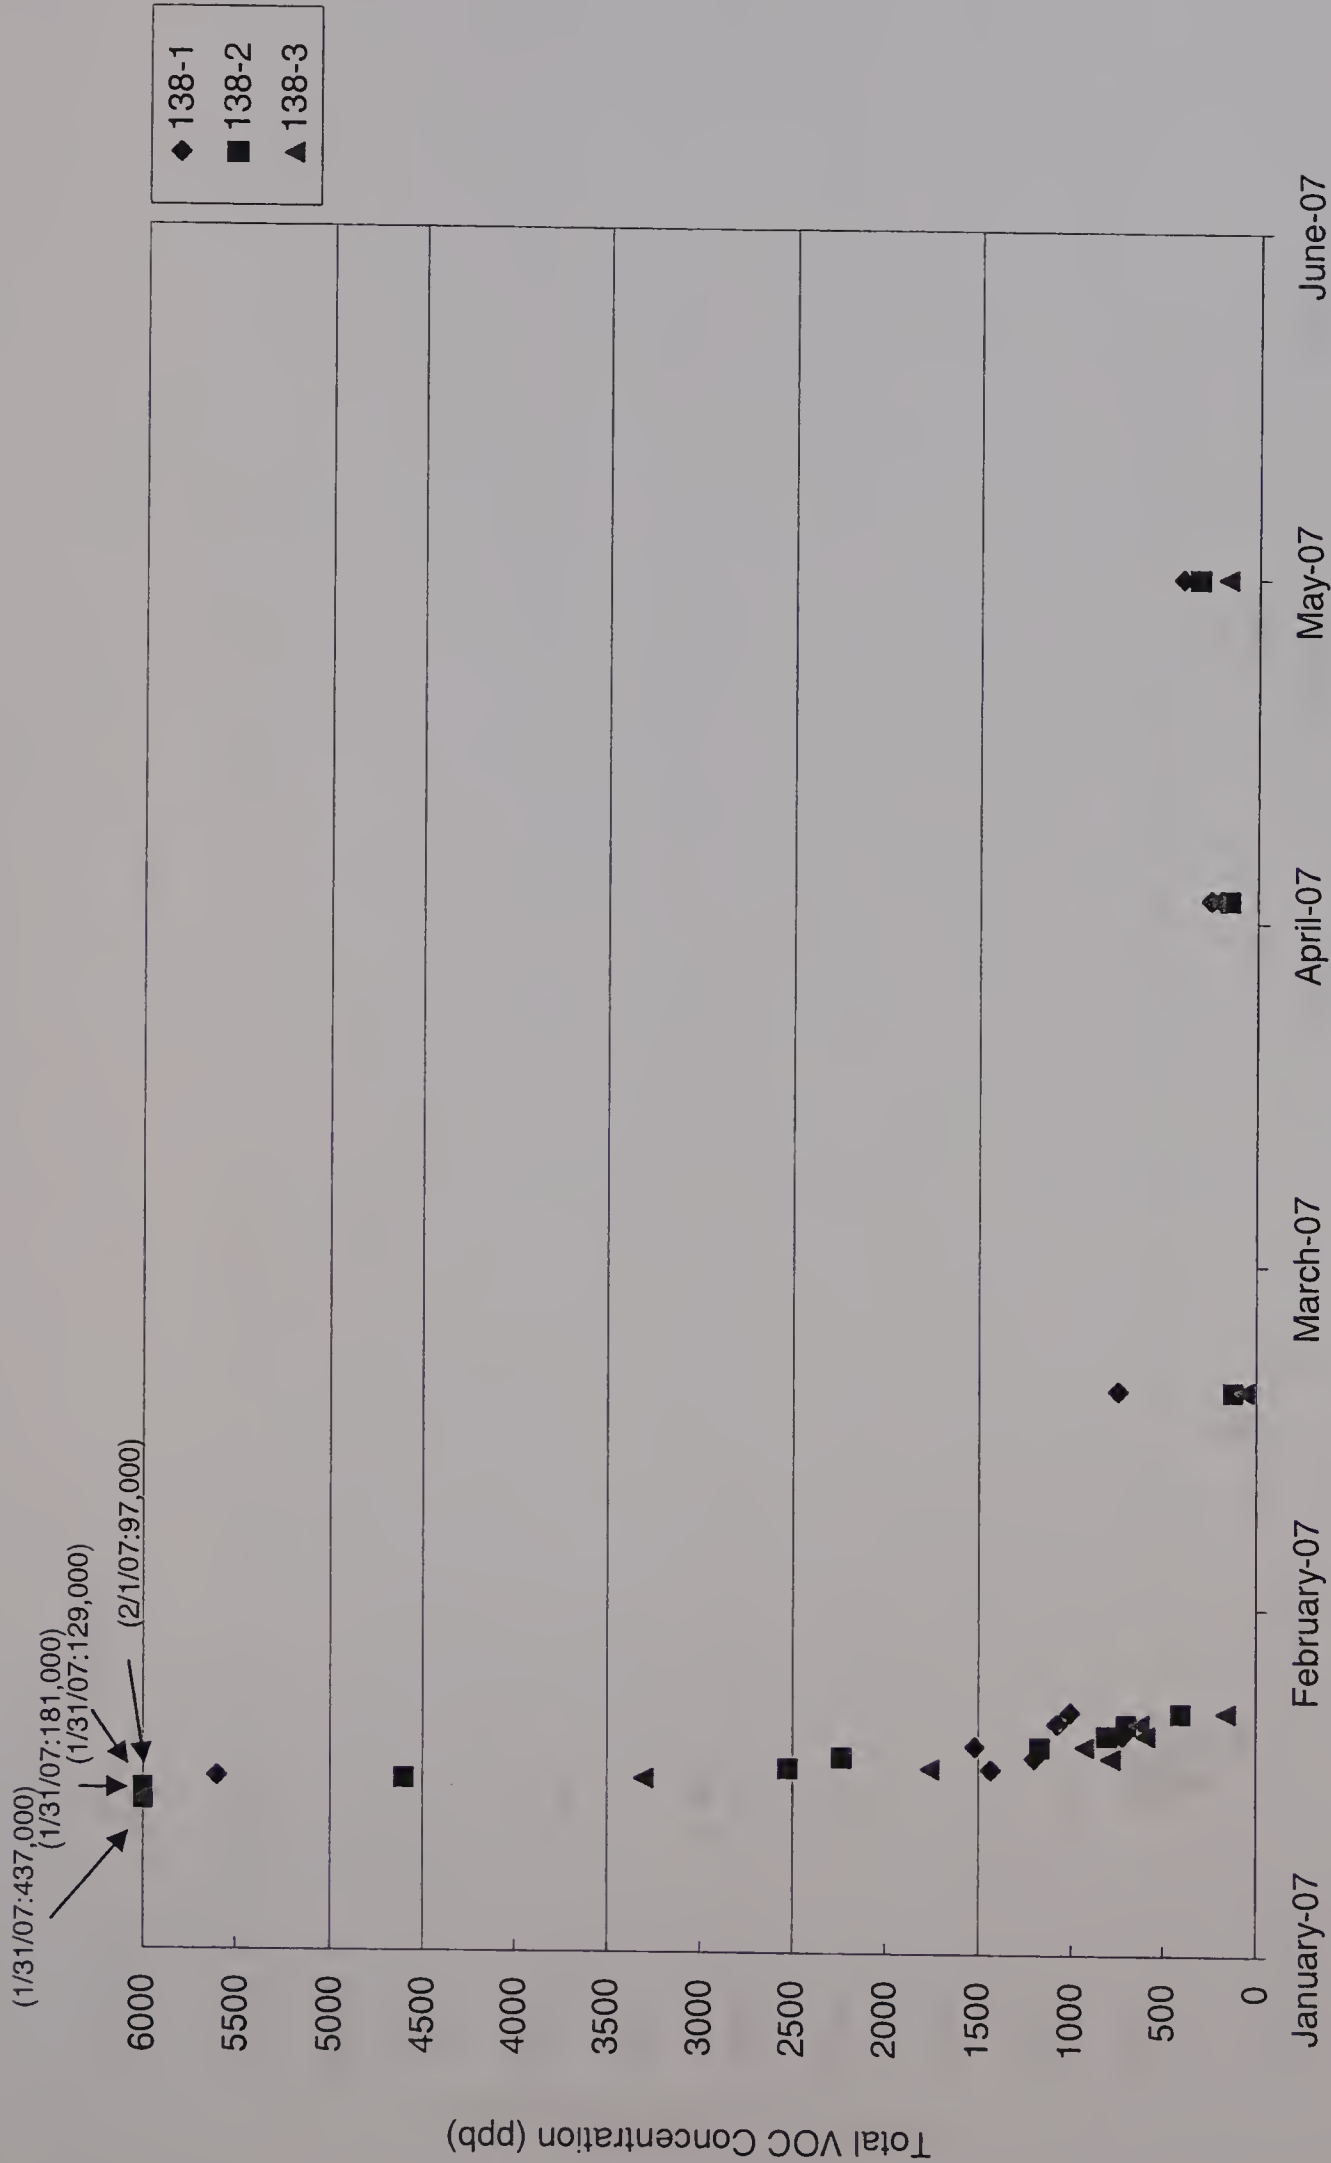
Graph 6

PID Monitoring Data: January 31, 2007 - May 31, 2007
Total VOC Concentrations by PID at Exterior Monitoring Points - Room 138
Capuano Center
Somerville, MA

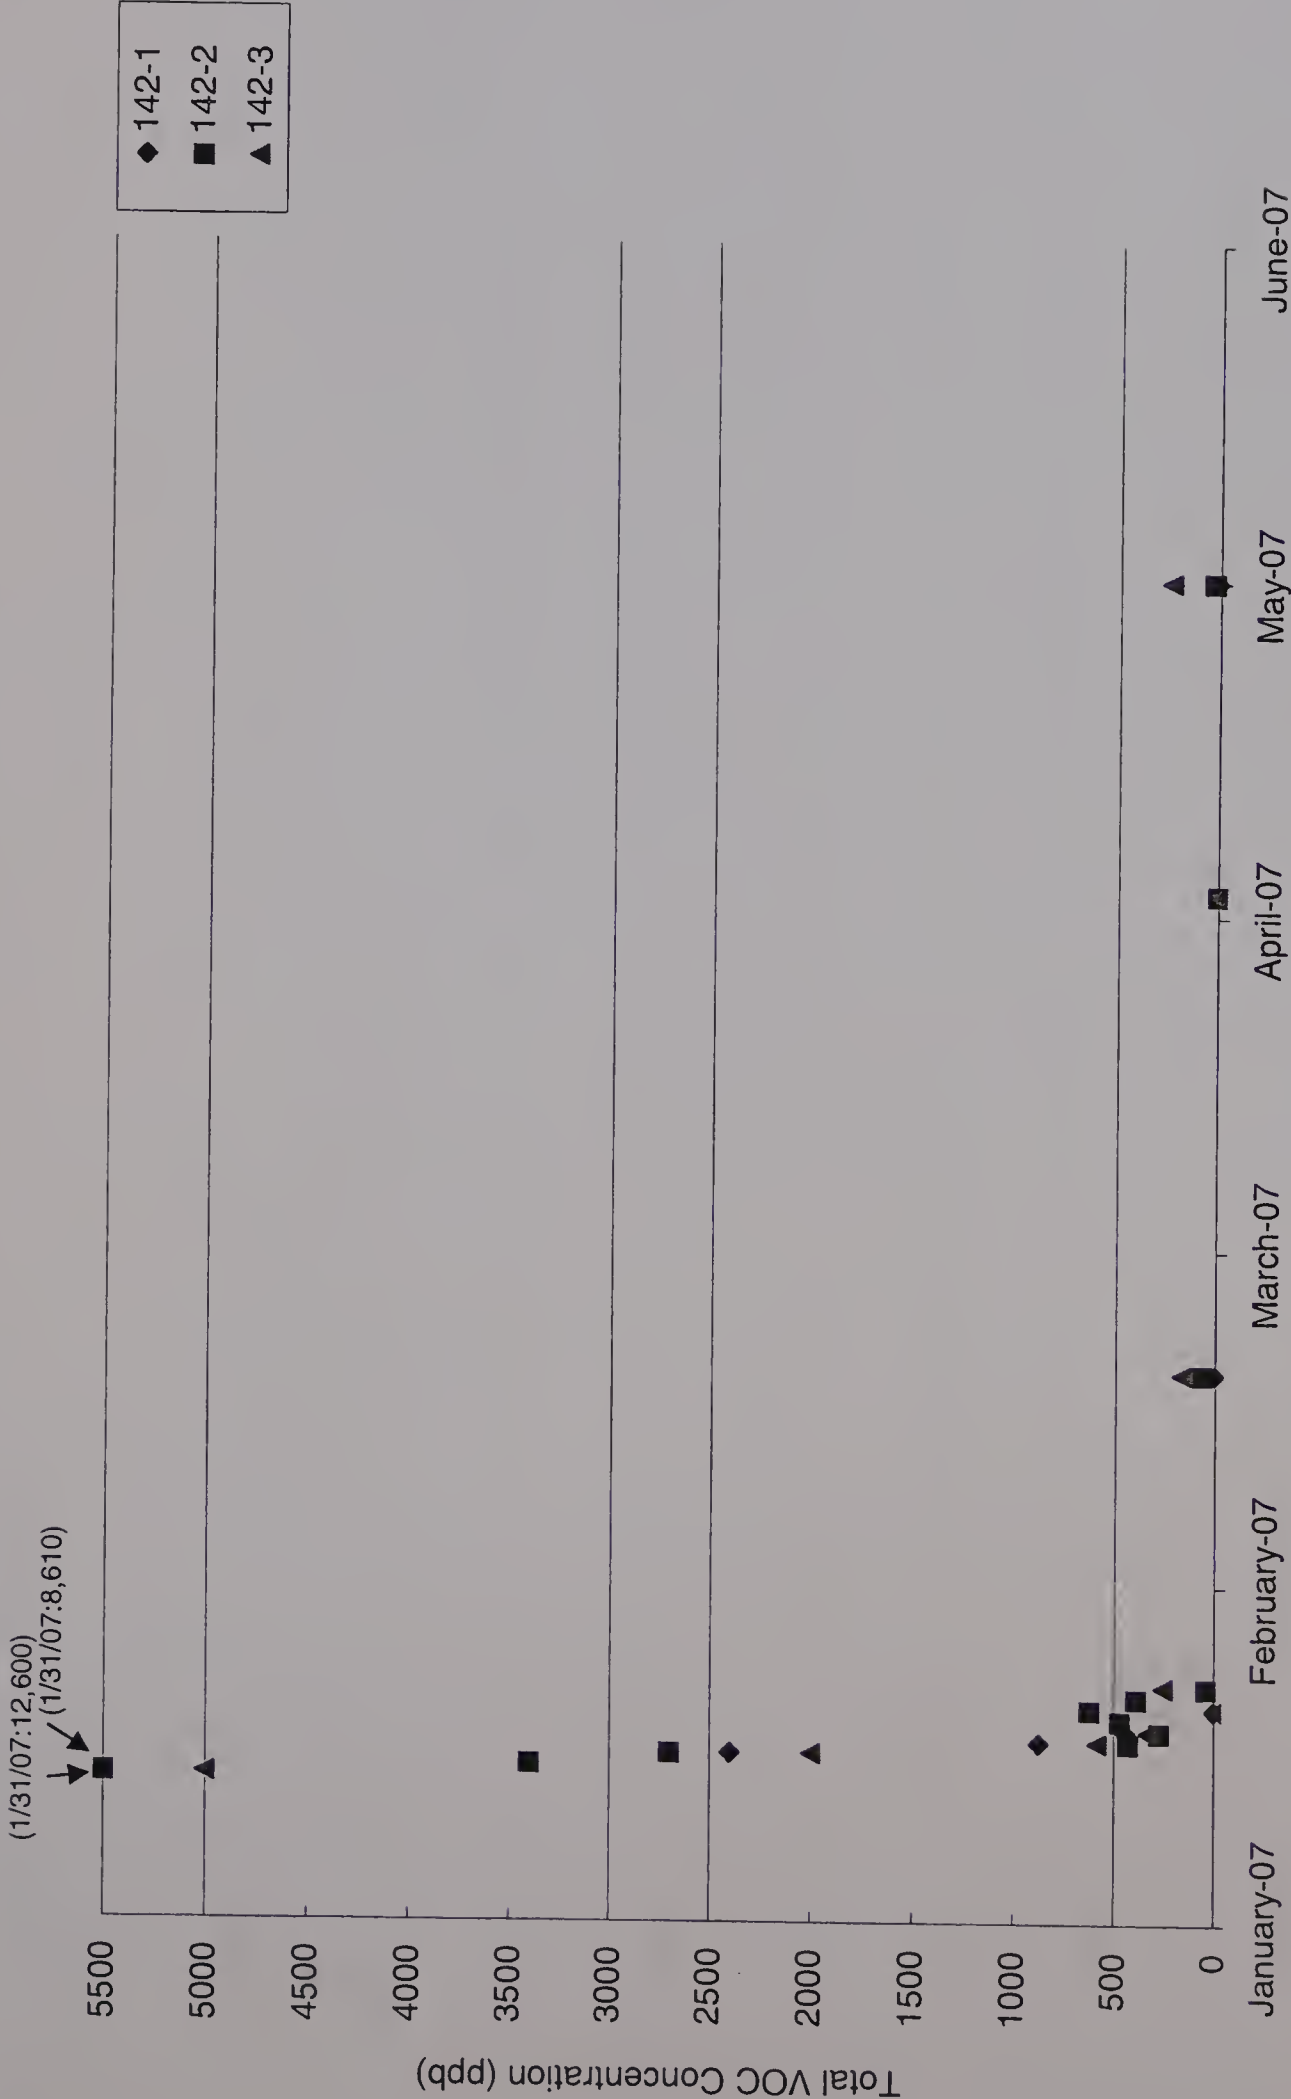
Graph 7

PID Monitoring Data: January 31, 2007 - May 31, 2007
Total VOC Concentrations by PID at Exterior Monitoring Points - Room 142
Capuano Center
Somerville, MA
